**Flood Control Project Maintenance
Levee Inspections**
LMA District Cover Sheet
Spring 2020 Levee Inspection Results

Sutter Maintenance Yard East Levee Sacramento River

Spring 2020 Levee Inspection Results

| Waterway | | | Bank | Unit Miles |
|--|---|---|---|---|
| Unit No. 01 Sacramento River | | | Left | 19.85 |

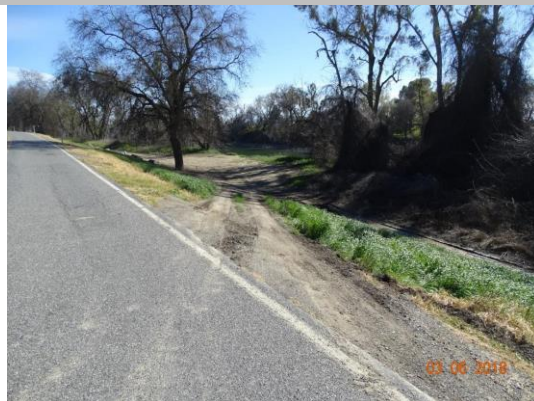
Photo 1 of 1 : SP_2020_ST0003_264_104_20200226_00020.jpg

View of the erosion along the waterside slope caused by vehicle traffic.

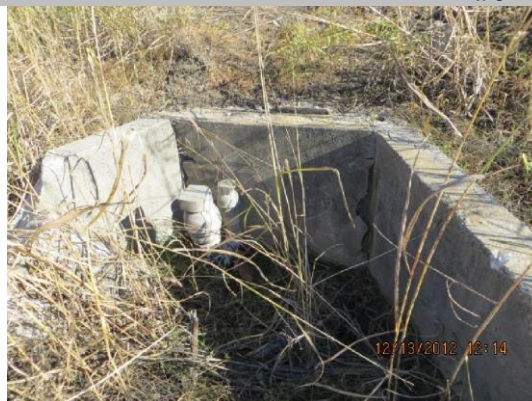
Photo 1 of 3 : UCIP_SP_2020_56021_47049.jpg

WS view: plugged concrete structure and siphon breakers

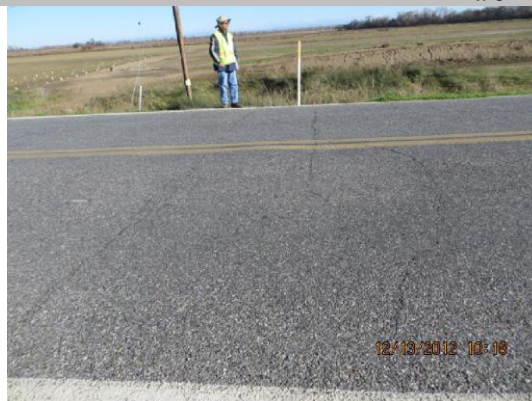
Photo 1 of 3 : UCIP_SP_2020_56042_47068.jpg

Crown view: transverse cracks on levee road.

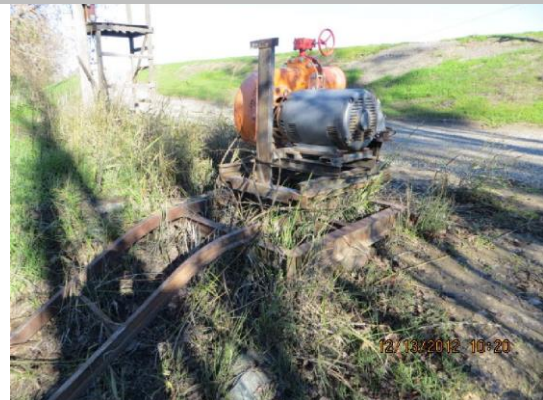
Photo 3 of 3 : UCIP_SP_2020_56042_47066.jpg

WS view: pump motor on the berm (found at water level in 2016)

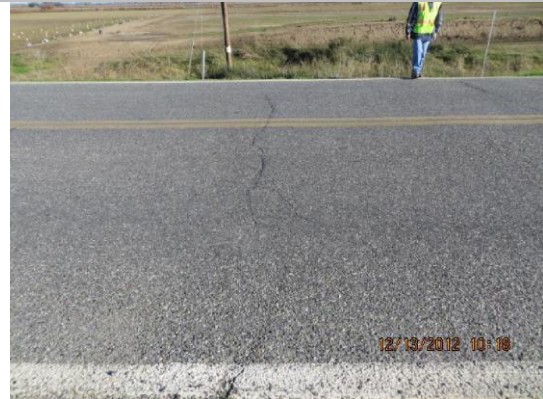
Photo 1 of 3 : UCIP_SP_2020_56070_47087.jpg

Crown view: transverse crack on levee road

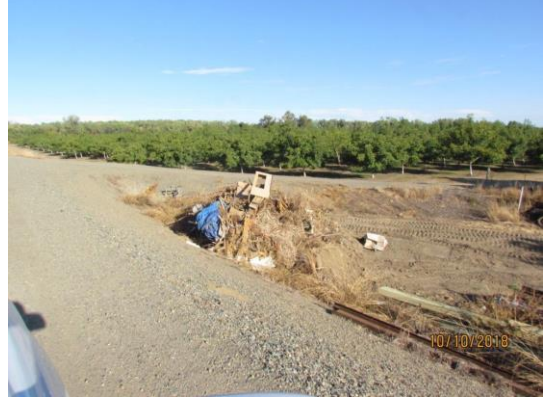
Photo 1 of 1 : SP_2020_ST0003_264_87_20200226_00014.jpg

View of the prunings and garbage along the landside toe.

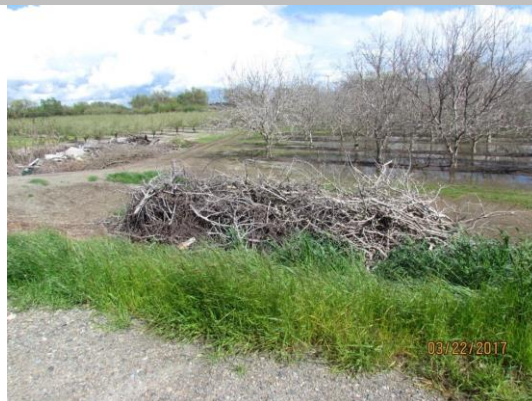
Photo 1 of 1 : SP_2020_ST0003_264_118_20200226_00022.jpg

View of the prunings at the landside toe.

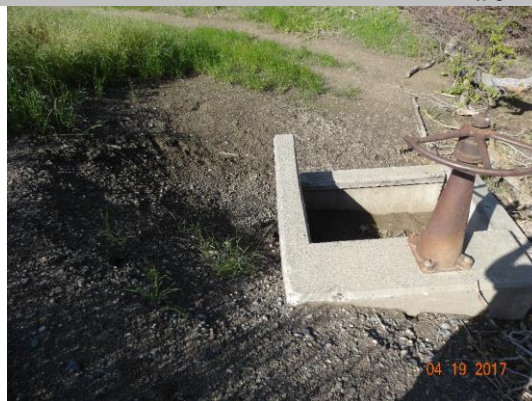
Photo 1 of 3 : UCIP_SP_2020_55543_77008.jpg

Depression around WS concrete box

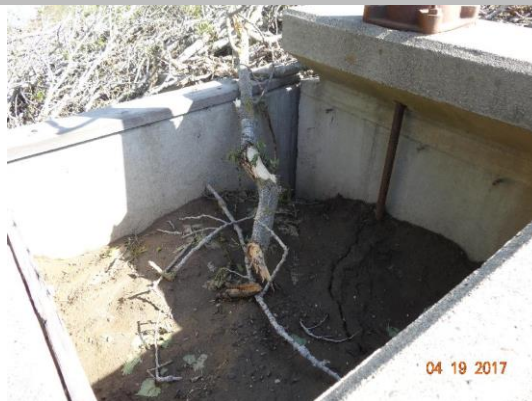
Photo 3 of 3 : UCIP_SP_2020_55543_77010.jpg

WS concrete box full of silt.

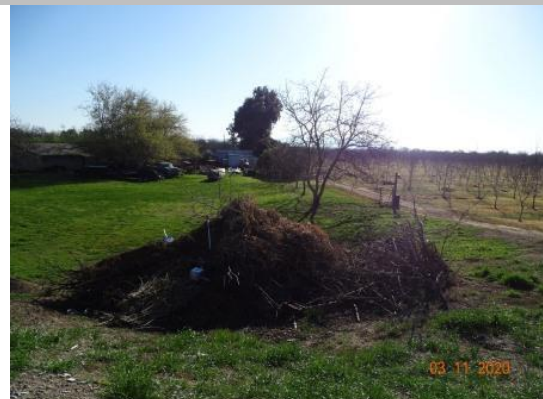
Photo 1 of 1 : SP_2020_ST0003_264_138_20200313_00282.jpg

View of the prunings pile at the landside toe. Spring 2020.

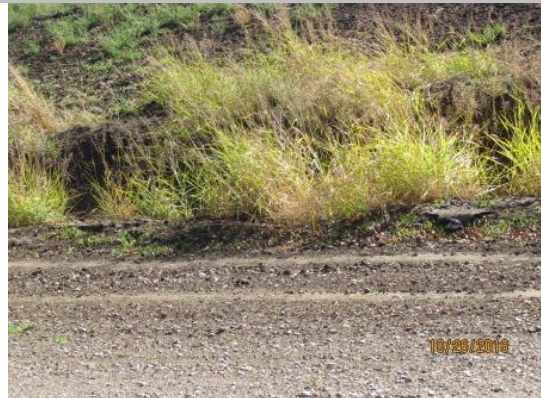
Photo 1 of 1 : SP_2020_ST0003_264_6_20200226_00003.jpg

View of the ditch along the landside toe.

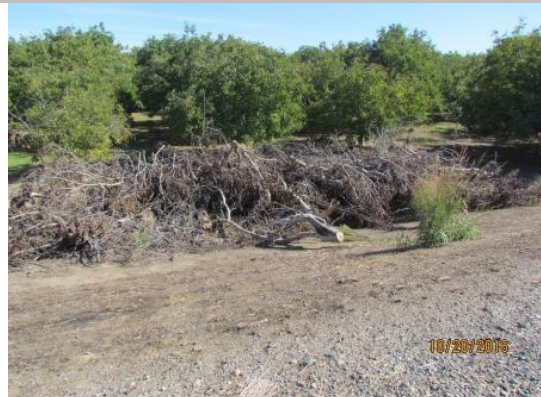
Photo 1 of 1 : SP_2020_ST0003_264_66_20200226_00010.jpg

View of the prunings along the landside toe.

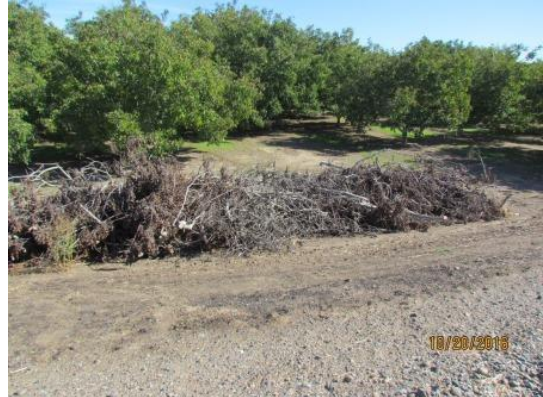
Photo 1 of 1 : SP_2020_ST0003_264_65_20200226_00009.jpg

View of the prunings along the landside toe.

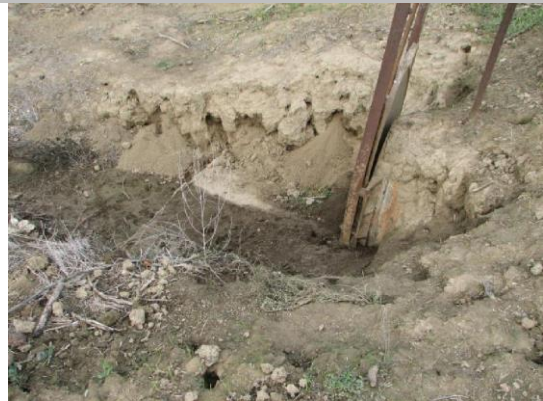
Photo 3 of 3 : UCIP_SP_2020_55610_47403.jpg

WS view: sloughing at outlet pipe

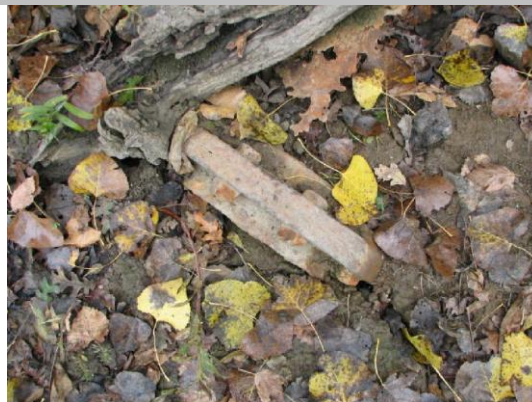
Photo 2 of 3 : UCIP_SP_2020_56037_47448.jpg

WS view: abandoned and ruined pipe
